Bessborough Housing Development
Blackrock, Co. Cork

Stage 1 Road Safety Audit

March 2022

MHL & Associates Ltd.
Consulting Engineers

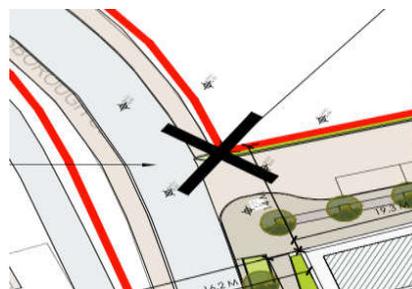
The drawings provided to the audit team do not include the provision of pedestrian crossings on the public road along desire lines. This could lead to collisions between pedestrians and vehicles along the public road.

The radius of the junction tie-in shown is not tangential with the roadside kerb, see Figure 2.2.1.1 above. This could lead to the mis-direction of vehicles entering the minor road resulting in side swiping pedestrians.

Provide a safe means for pedestrians to cross the public road.

Provide a suitable radius at the tie-in between the main road and the minor road.

2.2.1	Yes	Yes	This recommendation has been and implemented as requested – please refer drawing number . <i>SB-2020-106-200-MEADOWS SITE LAYOUT PLAN</i>

2.2.2	Yes	Yes	The turning radius has been adjusted per recommendation. please refer drawing number: <i>SB-2020-106-200-MEADOWS SITE LAYOUT PLAN</i>	
2.2.3	Yes	Yes	The arrangement has been revised to allow for clearer through traffic from the East with provision of safe turning for creche drop off please refer drawing number: <i>SB-2020-106-200-MEADOWS SITE LAYOUT PLAN</i>

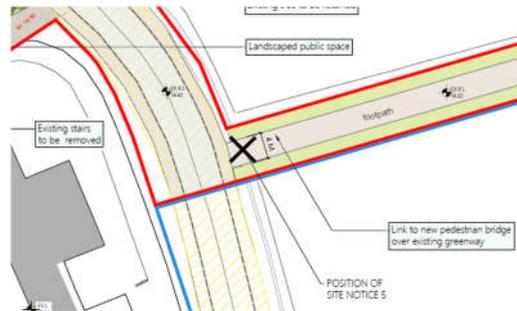
Figure 2.3.1.1

The drawings provided to the audit team do not include the provision of any pedestrian crossing on the public road for pedestrians wishing to access the proposed footbridge. This could lead to collisions between pedestrians and vehicles along the public road.

Provide a safe crossing point for pedestrians to access the proposed pedestrian footbridge.

2.3.1	Yes	Yes	Crossing provision added per recommendation . please refer drawing number: <i>SB-2020-107-200-FARM SITE LAYOUT PLAN</i>	
2.3.2	Yes	Yes	Guard rail provided to push desire line further west - please refer drawing number: <i>SB-2020-107-200-FARM SITE LAYOUT PLAN</i>

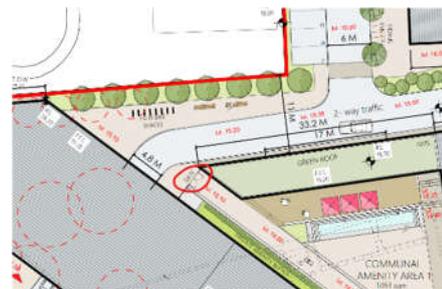
Figure 2.3.2.1

Vehicles approaching the communal amenity area gate from the east do not have clear forward visibility to the gate. This could lead to collisions between vehicles and vulnerable road users, in particular with pedestrians crossing the road to access the bike spaces directly across from the gate.

Design proposals, such as a pedestrian railing, should be considered to block the pedestrian desire line to the bike spaces across the road. Pedestrians crossing at a location further west of this point will have better sightlines to/from vehicles travelling within the development.

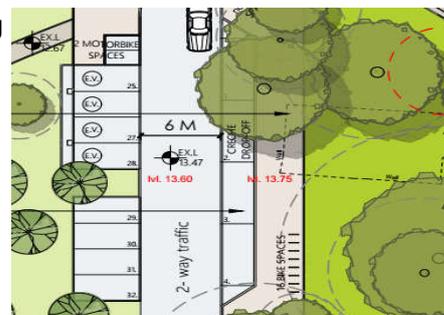
Figure 2.3.3.1

It is not certain where vehicles accessing the creche are to turn around following drop off. This could lead to unsafe turning manoeuvres being taken by vehicles during peak creche traffic times.

Ensure creche users are aware of the designated turning location within the development.

2.3.3	Yes	Yes	Clear turning area provided to at cul de sac T junction further to south away from creche drop off for safety

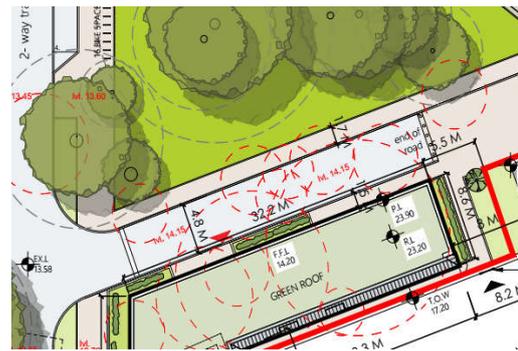
Figure 2.3.4.1

The internal road to the south of Communal Amenity Area 2 appears to end abruptly. It is not certain what is the purpose of this road and where vehicles coming to the end of this road are to turn around. This could lead to unsafe turning manoeuvres being undertaken by vehicles.

Provide clarity to the Audit team on the purpose of this road and to provide an appropriate turning area for road users.

<p>please refer drawing number:</p> <p><i>SB-2020-107-200-FARM SITE LAYOUT PLAN</i></p>	
2.3.4	Yes	Yes	<p>This is a low trafficked area for service collection and emergency vehicle access where turning is facilitated at the T junction.</p> <p>please refer drawing number:</p> <p><i>SB-2020-107-200-FARM SITE LAYOUT PLAN</i></p>
