BESSBOROUGH, CORK

Cultural Heritage

Appendix 10.2: General Photographic Record

1. Introduction

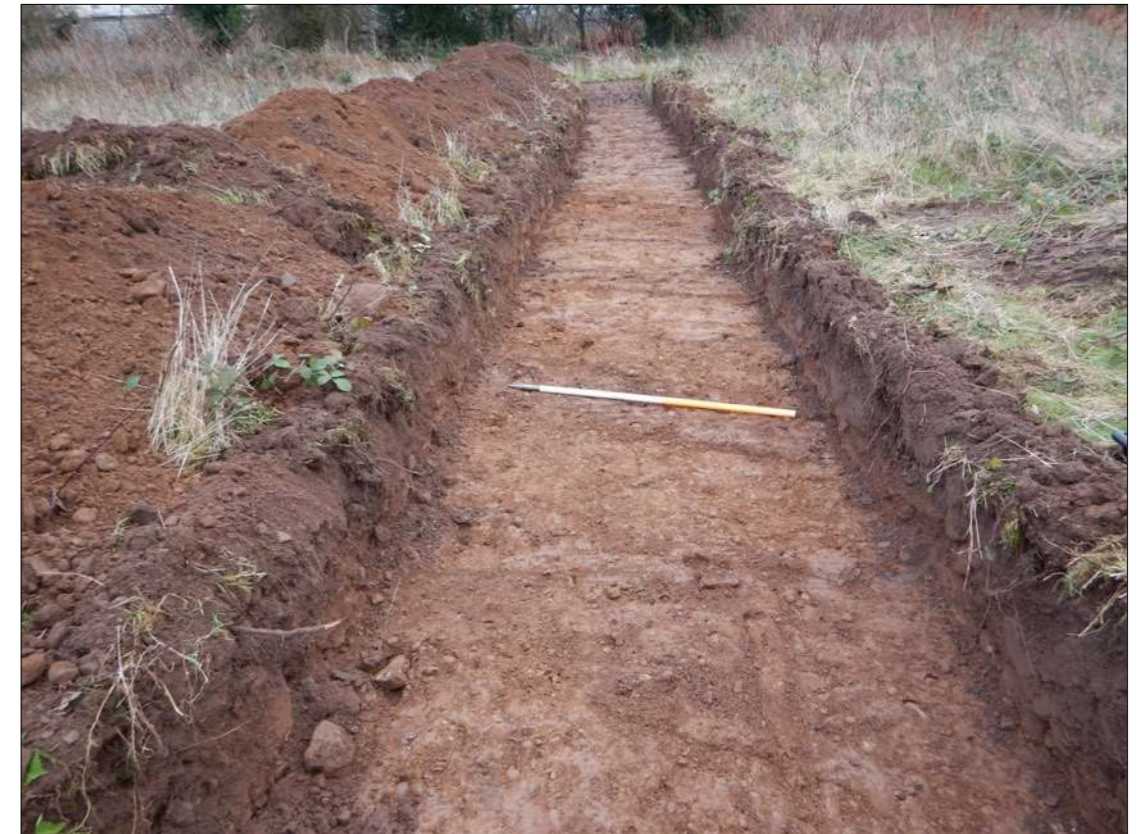
Plate 16 Series of agricultural furrows crossing eastern portion of Trench 6, looking northeast

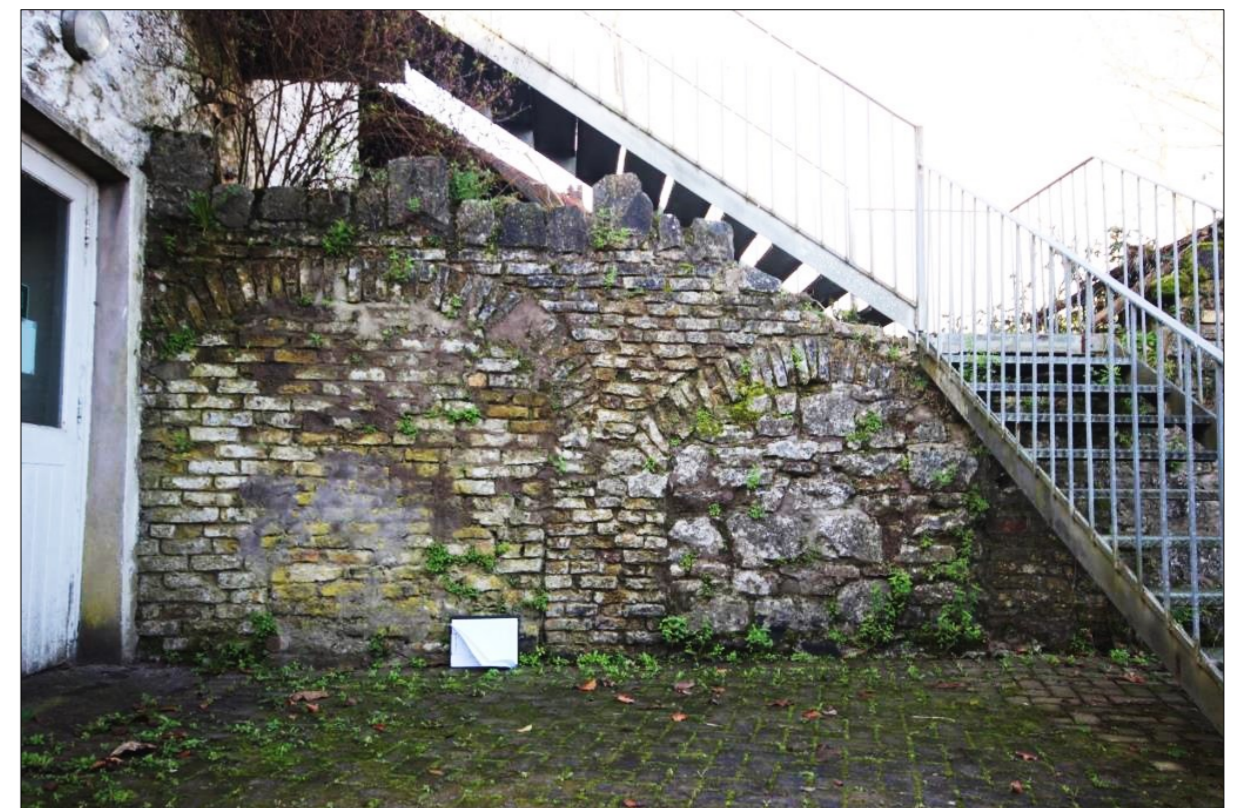
Plate 7: Blocked up brick arches in boundary wall to east of Building A

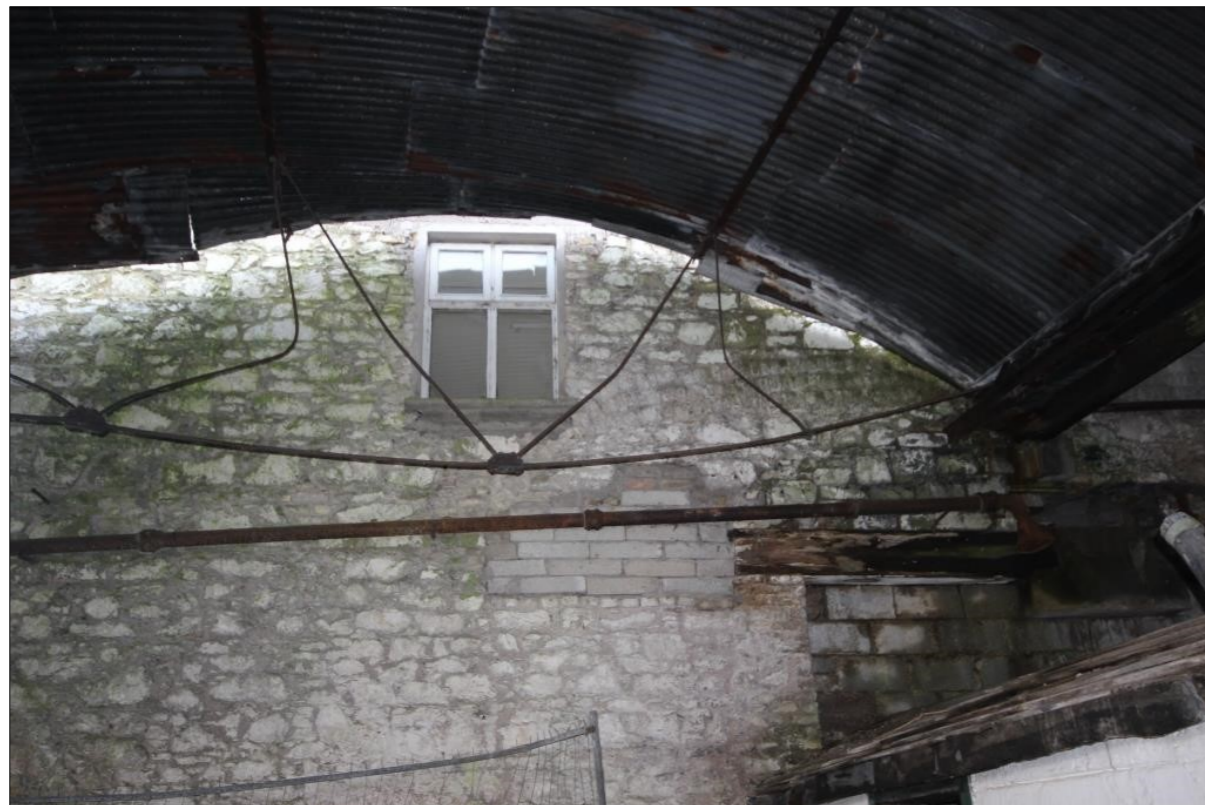
Plate 9: Blocked-up openings in north-western elevation of Building A

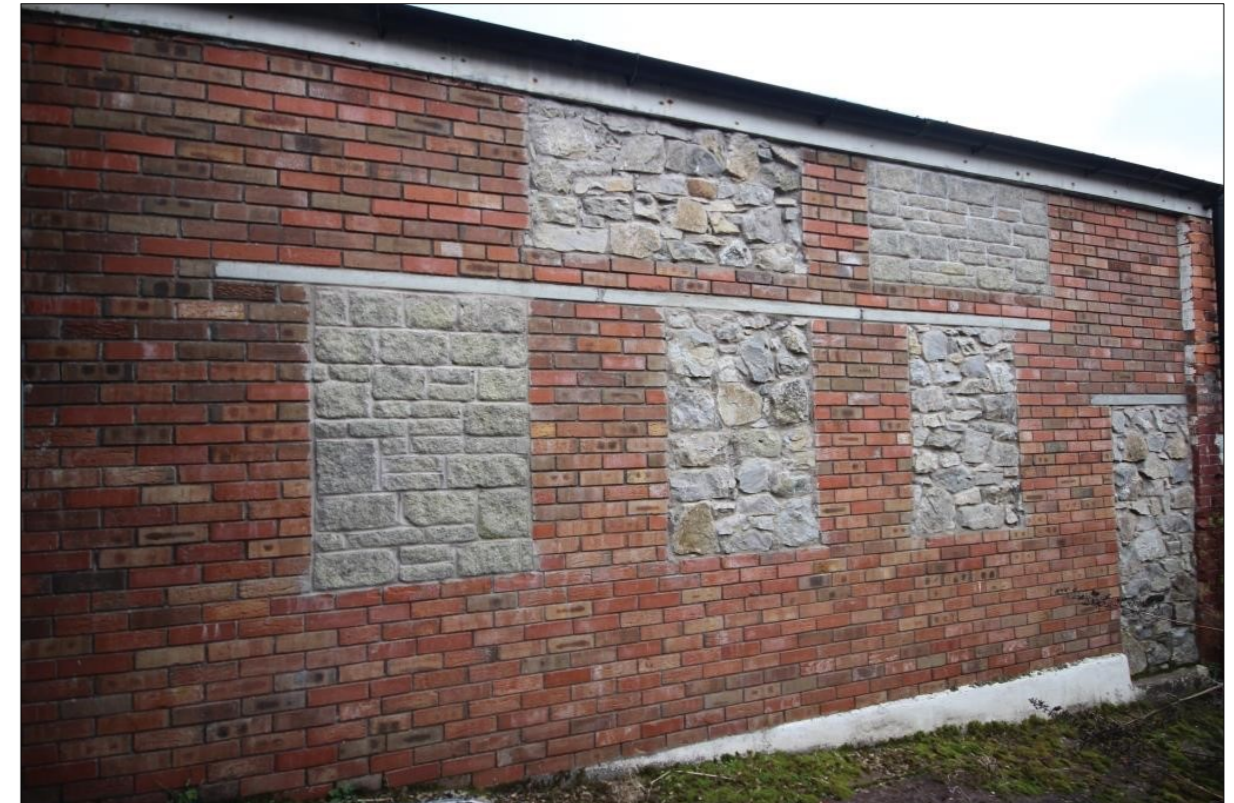
Plate 14: Northern end of western elevation of Building B rebuilt with modern brick and stone finishes

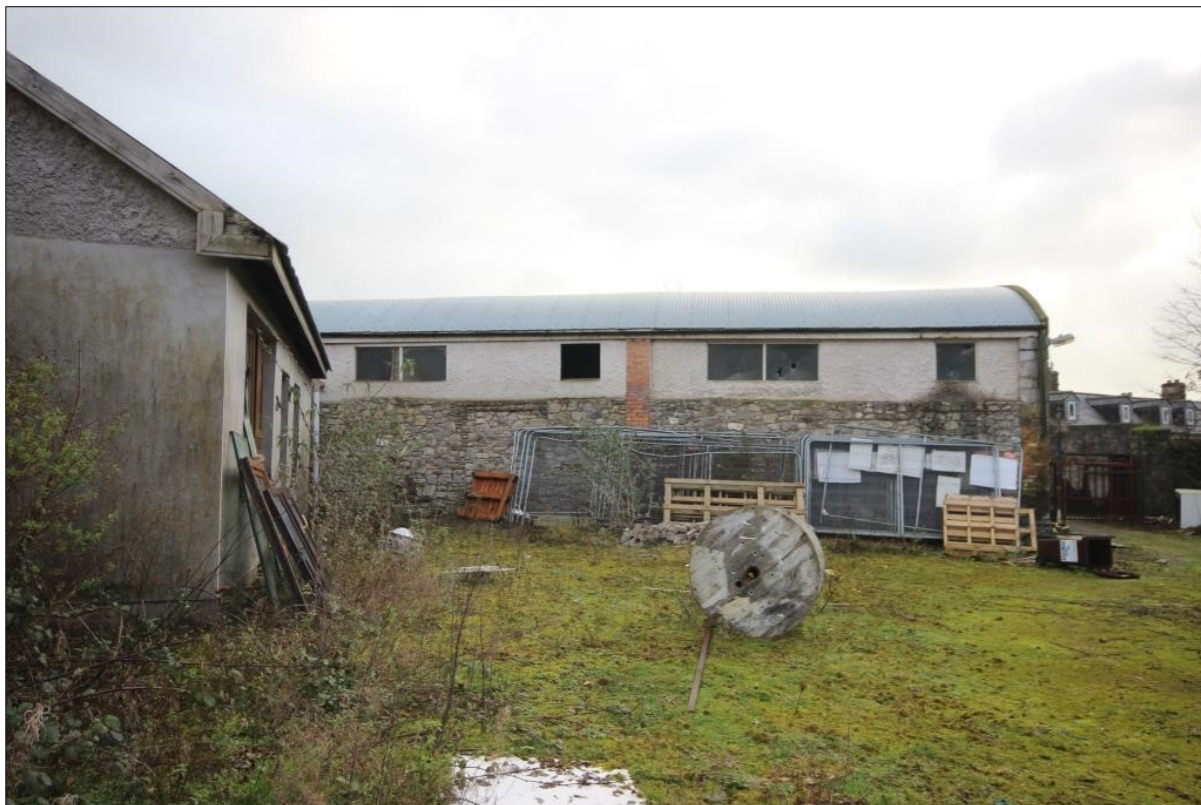
Plate 13: Western elevation of Building B. Note upper section rebuilt

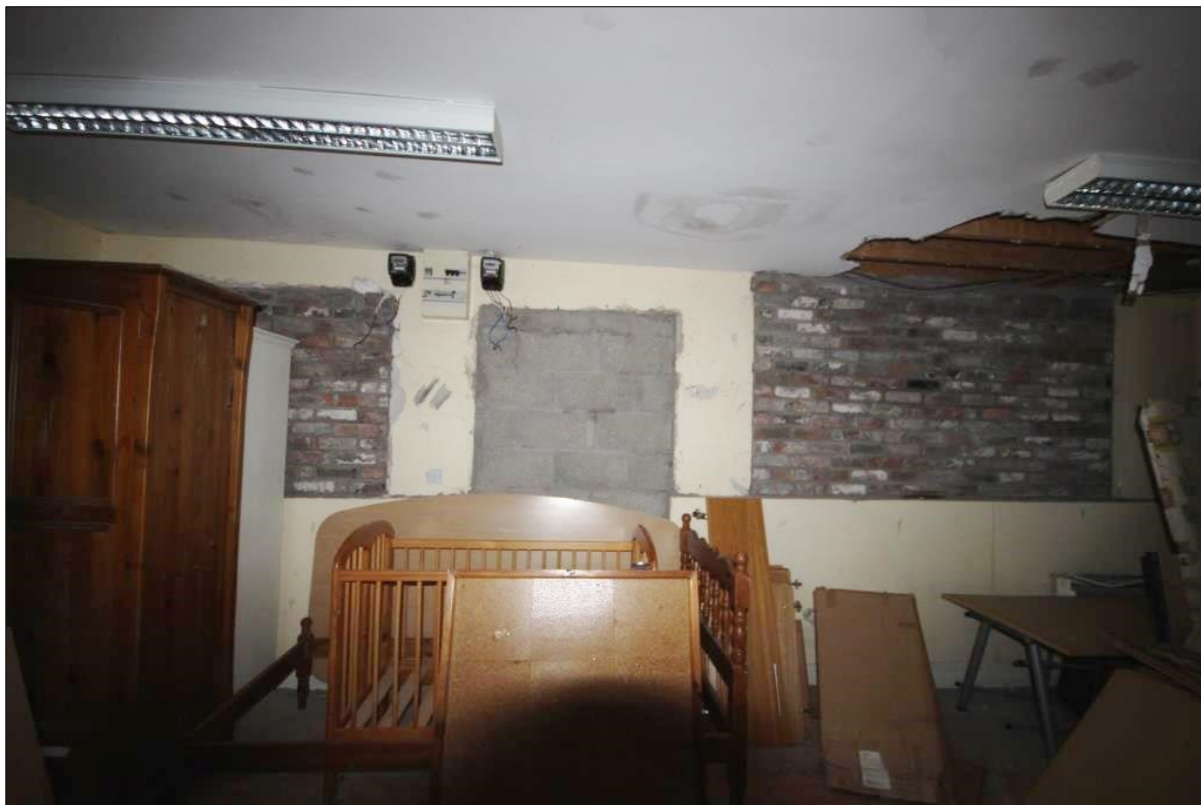
Plate 17: Interior of western wall of Building B with blocked-up openings

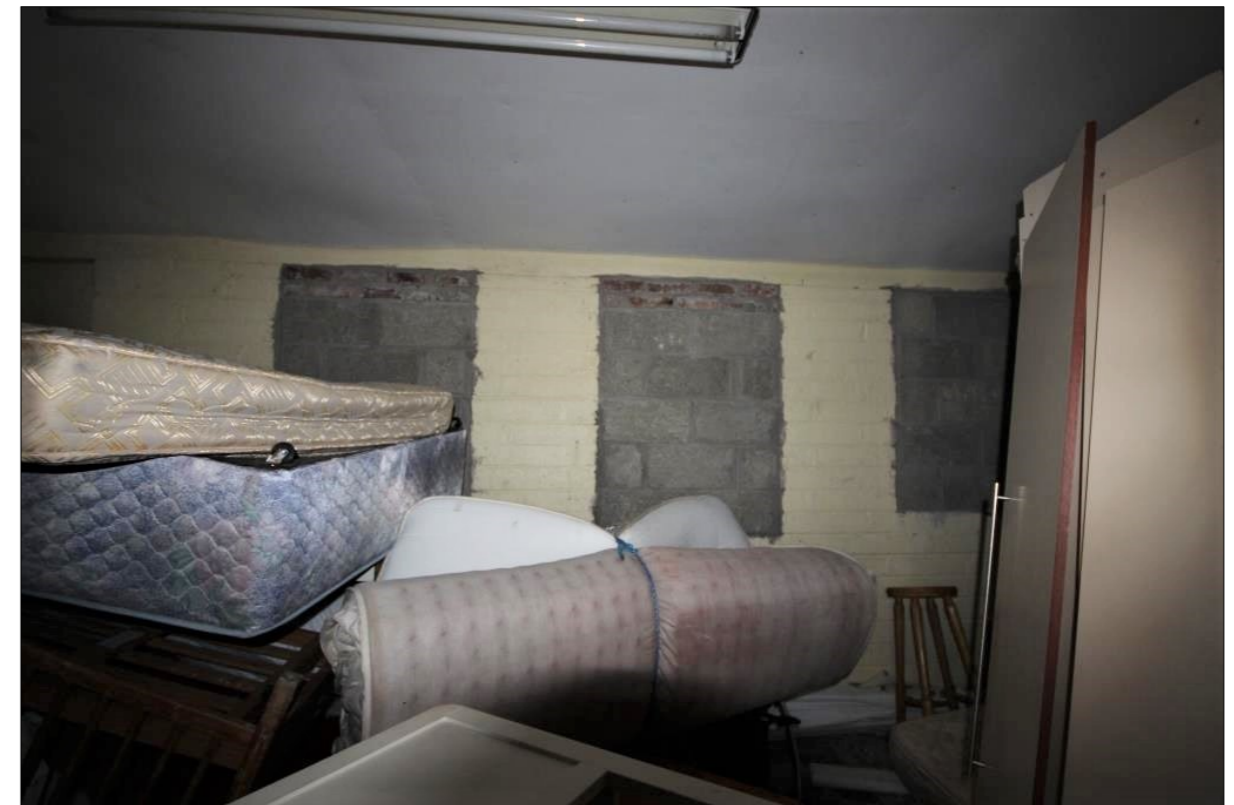
Plate 19: Interior of western wall of Building B with blocked-up openings

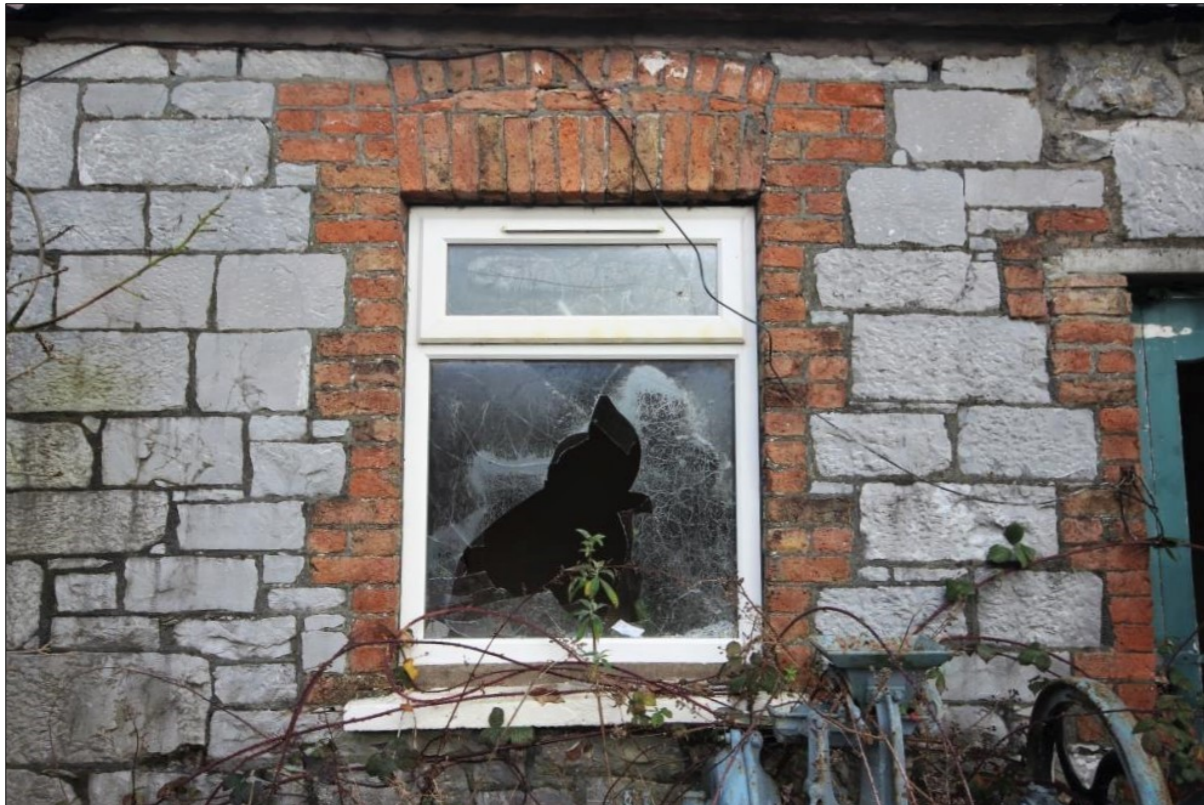
Plate 28: Window detail on southern elevation of Building E with replacement uPVC frame

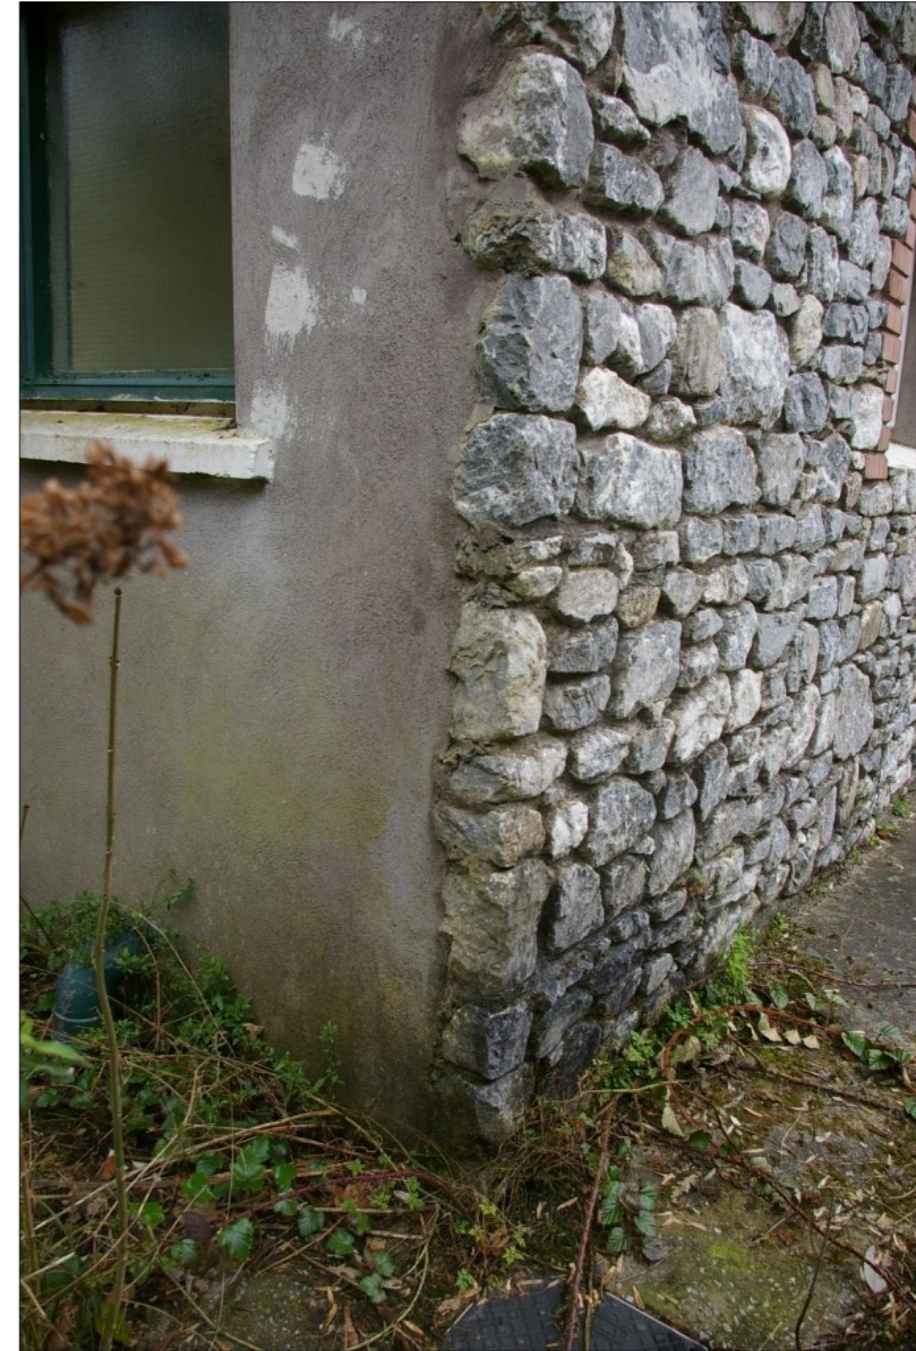
Plate 34: Detail of modern stonework and render on corner of southern elevation of Building G

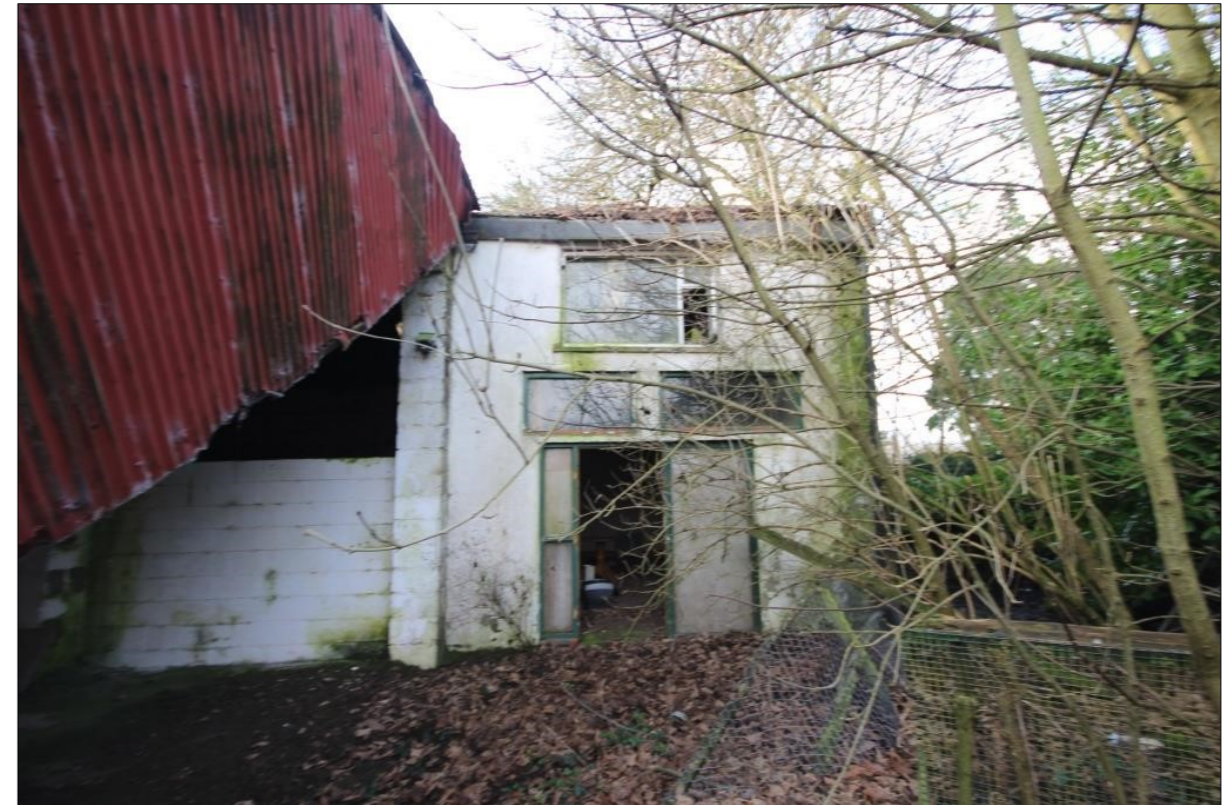
Plate 41: Modern concrete built addition to northern portion of Building H

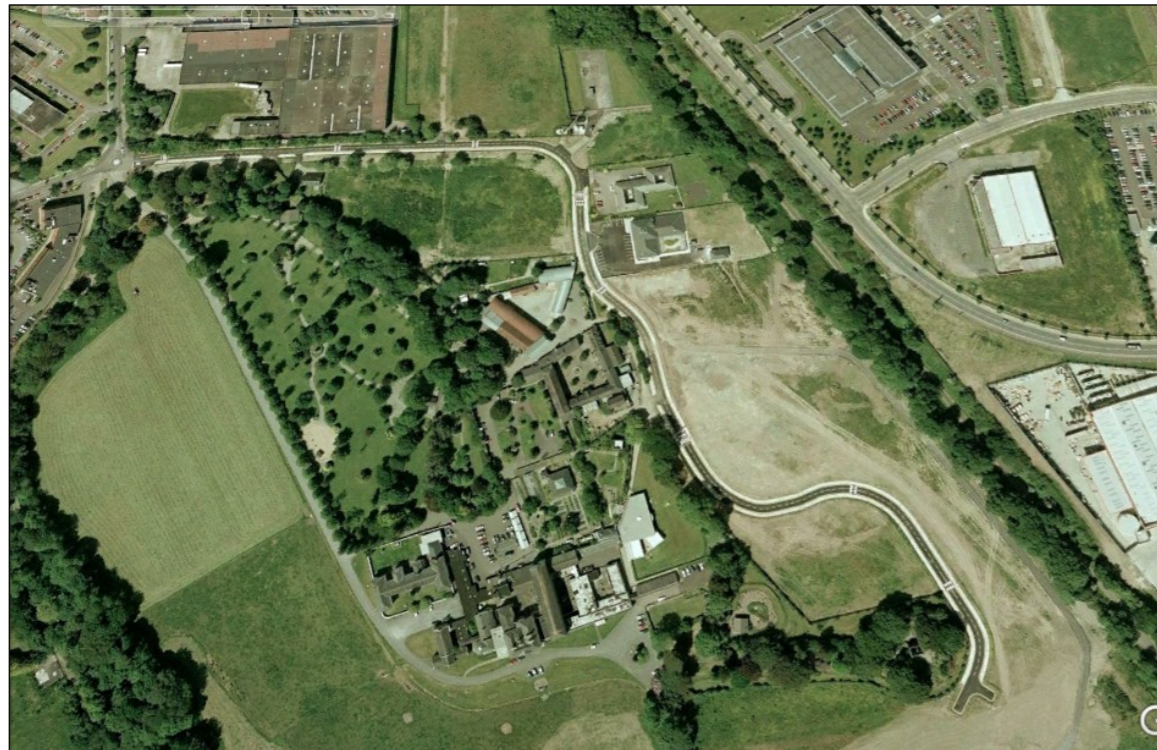
4.2 cursory examination of the available aerial imagery shows substantial ground disturbance in the eastern portion of this site – here referred to as ‘the Meadows’ – prior to June 2006 (Figure 2).

Figure 2: Aerial image of Bessborough in June 2006 showing disturbed ground at east (source: Google Earth Pro)
