BESSBOROUGH, CORK

Cultural Heritage

Appendix 10.2: General Photographic Record

1. Introduction

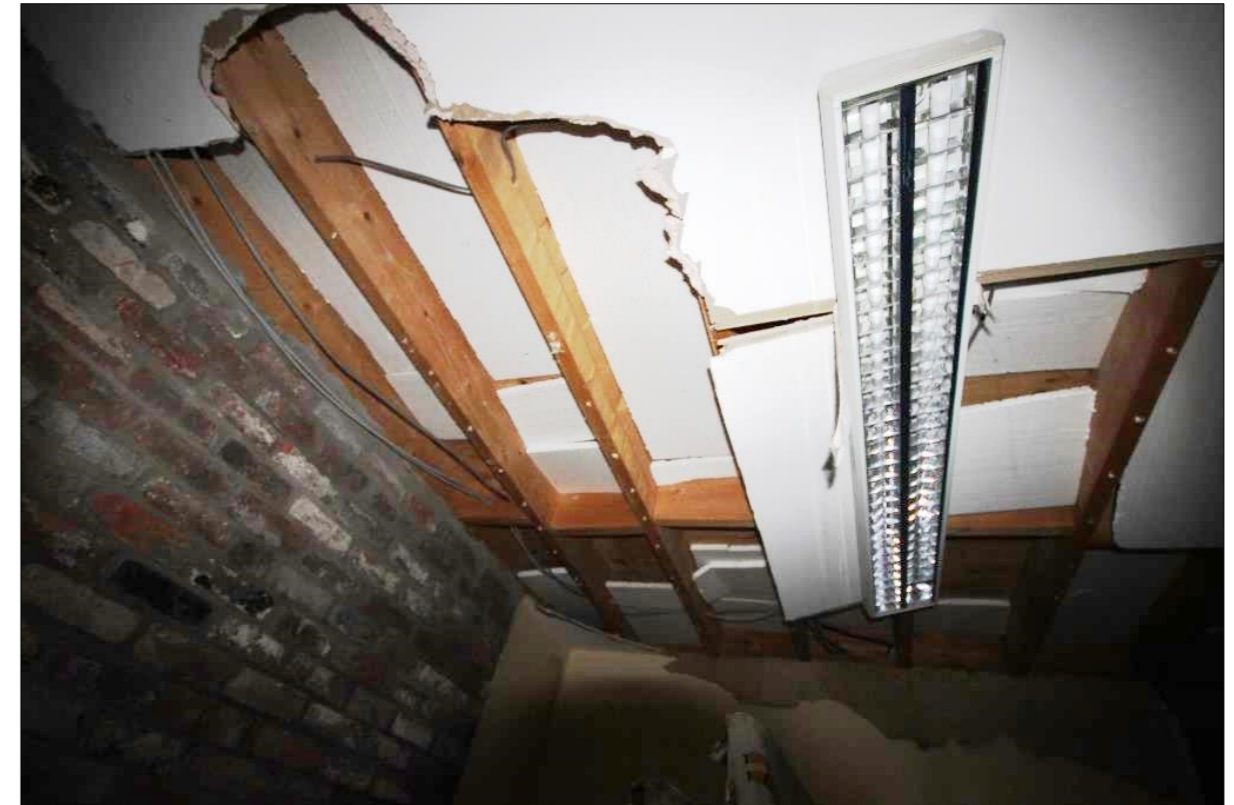
Plate 18: Modern floor joists in Building B

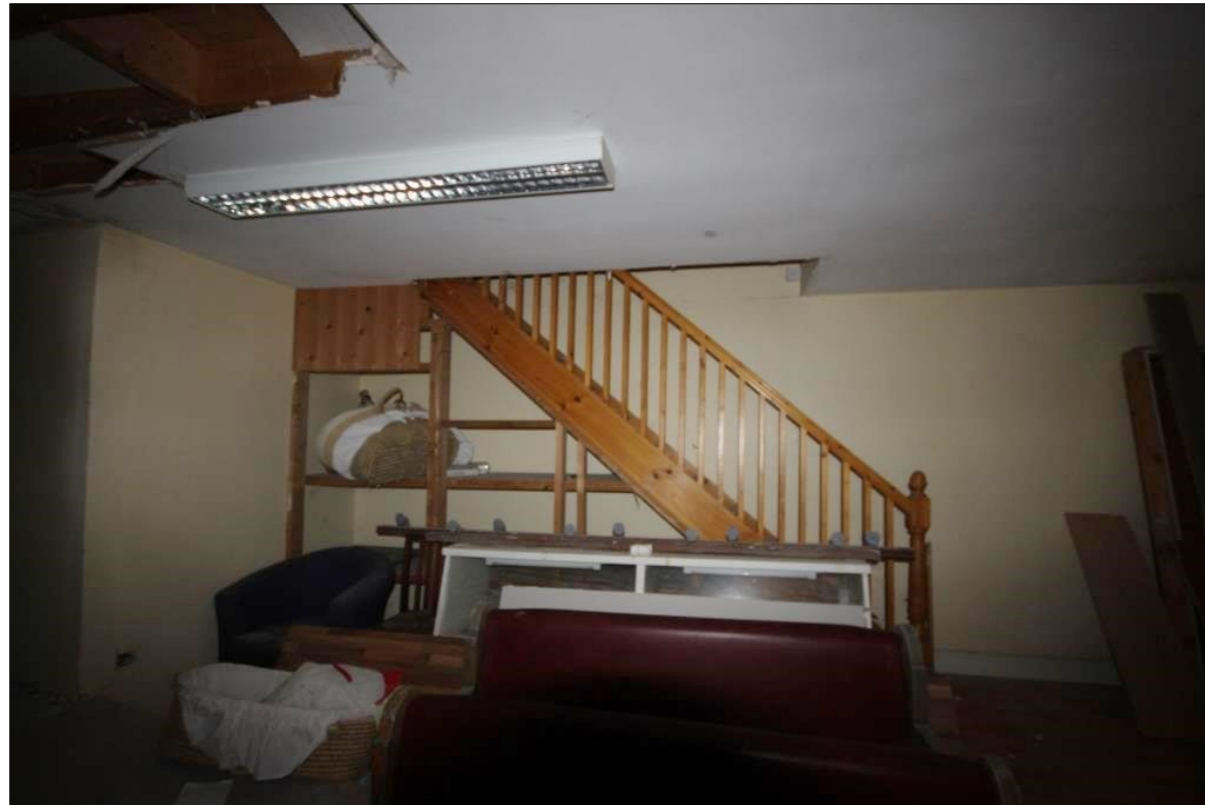
Plate 20: Modern staircase in ground floor room B-GF Building B

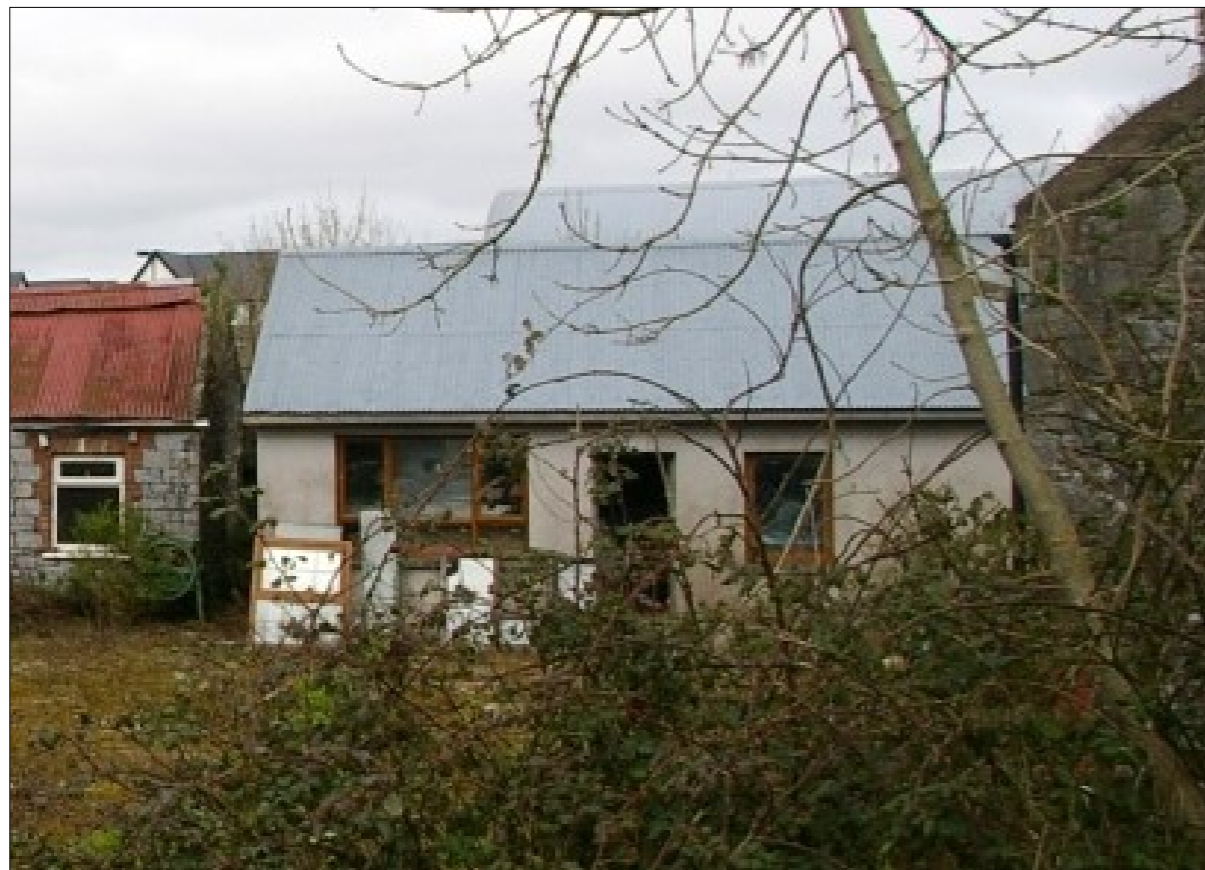
Plate 25: Southern elevation of modern structure Building D

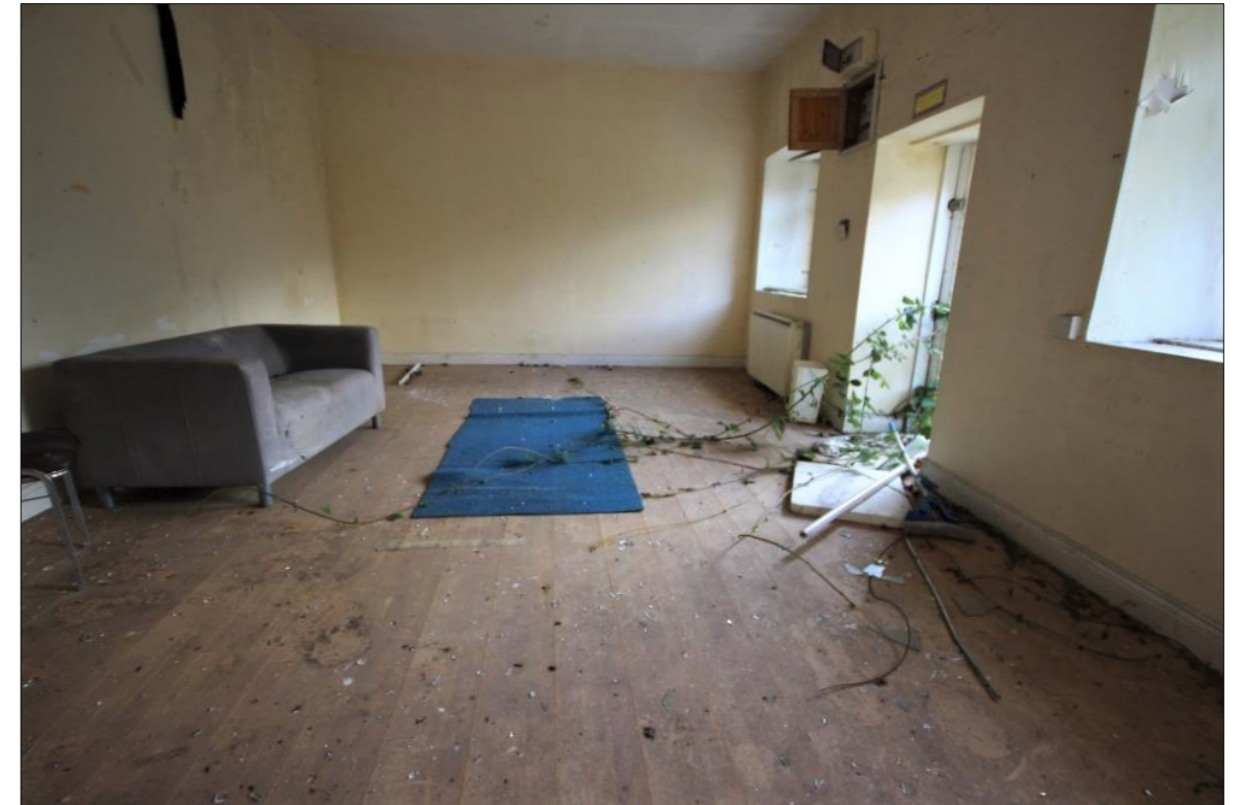
Plate 30: Interior view of Building E with modern floor, ceiling and wall finishes

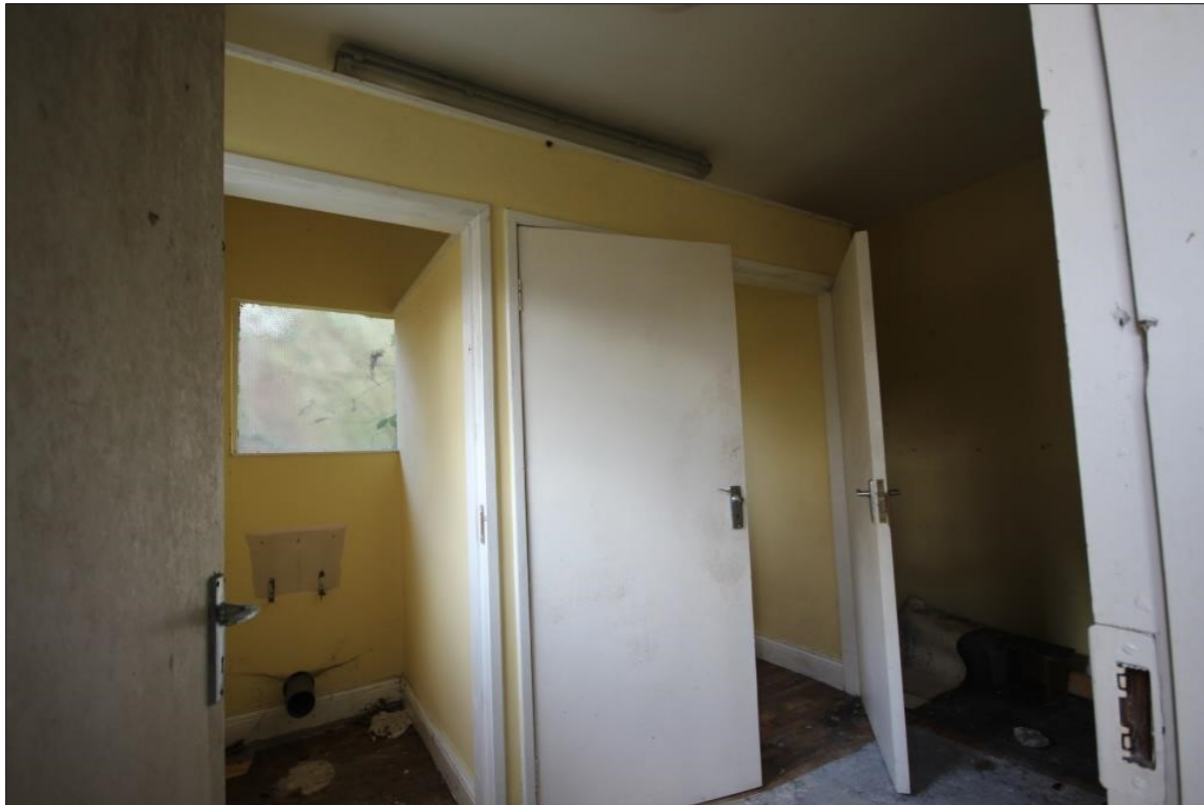
Plate 35: Interior of Building G with modern finishes

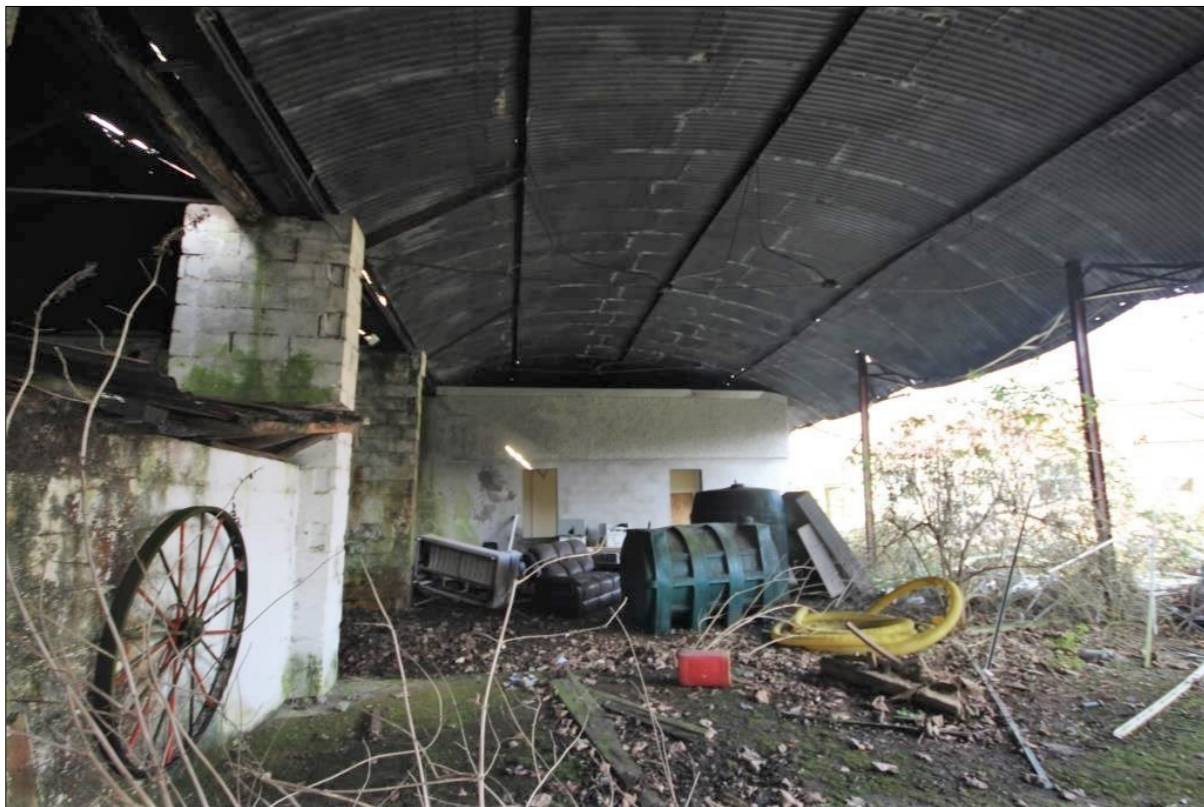
Plate 40: Interior of eastern portion of Building H looking north with modern concrete addition

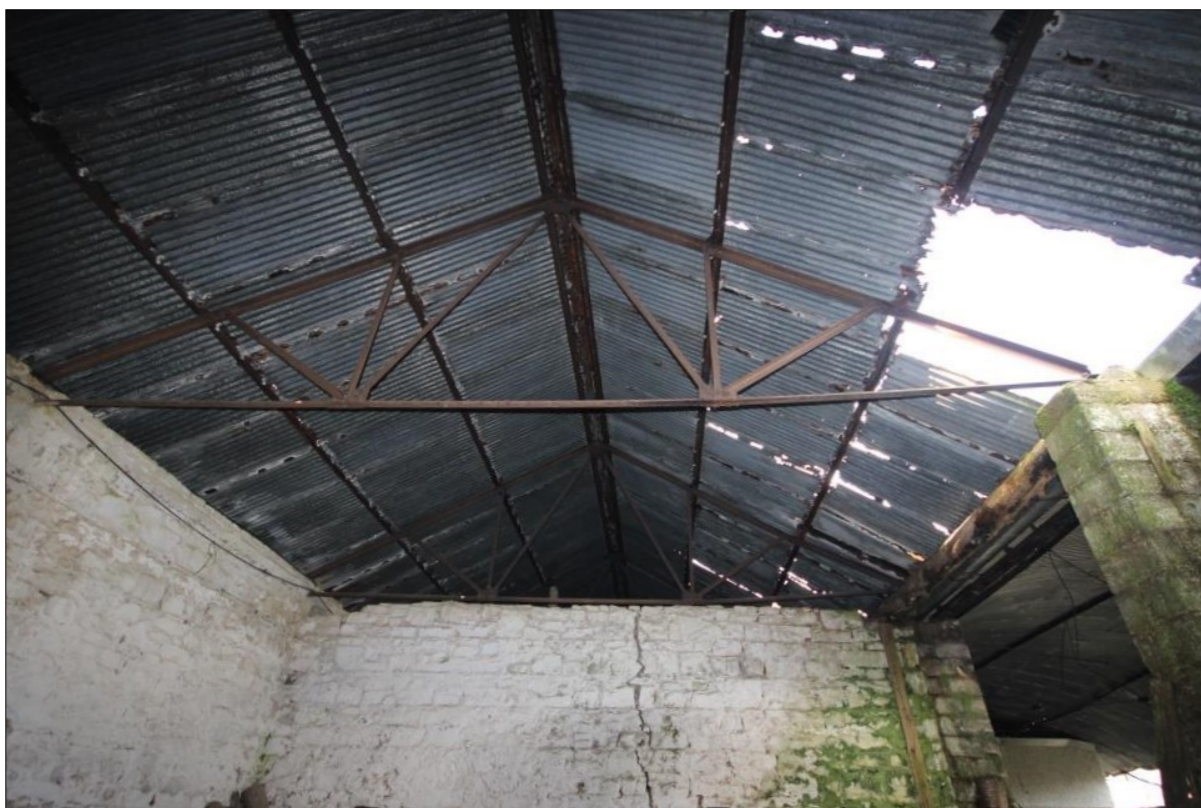
Plate 44: Steel truss roof in eastern section of Building
