BESSBOROUGH, CORK

APPENDIX 3

Alternatives Considered

Document Title: Historic Landscape Assessment Report
Issue Date: 18th August 2020
Site Location: Besborough Demesne, Mahon, Cork
Townland: Ballinure
Irish National Grid Reference: (E,N) 571800, 570250
Client: Estuary View Enterprises 2020 Limited
Report Author: Mike Waldvogel, MILI

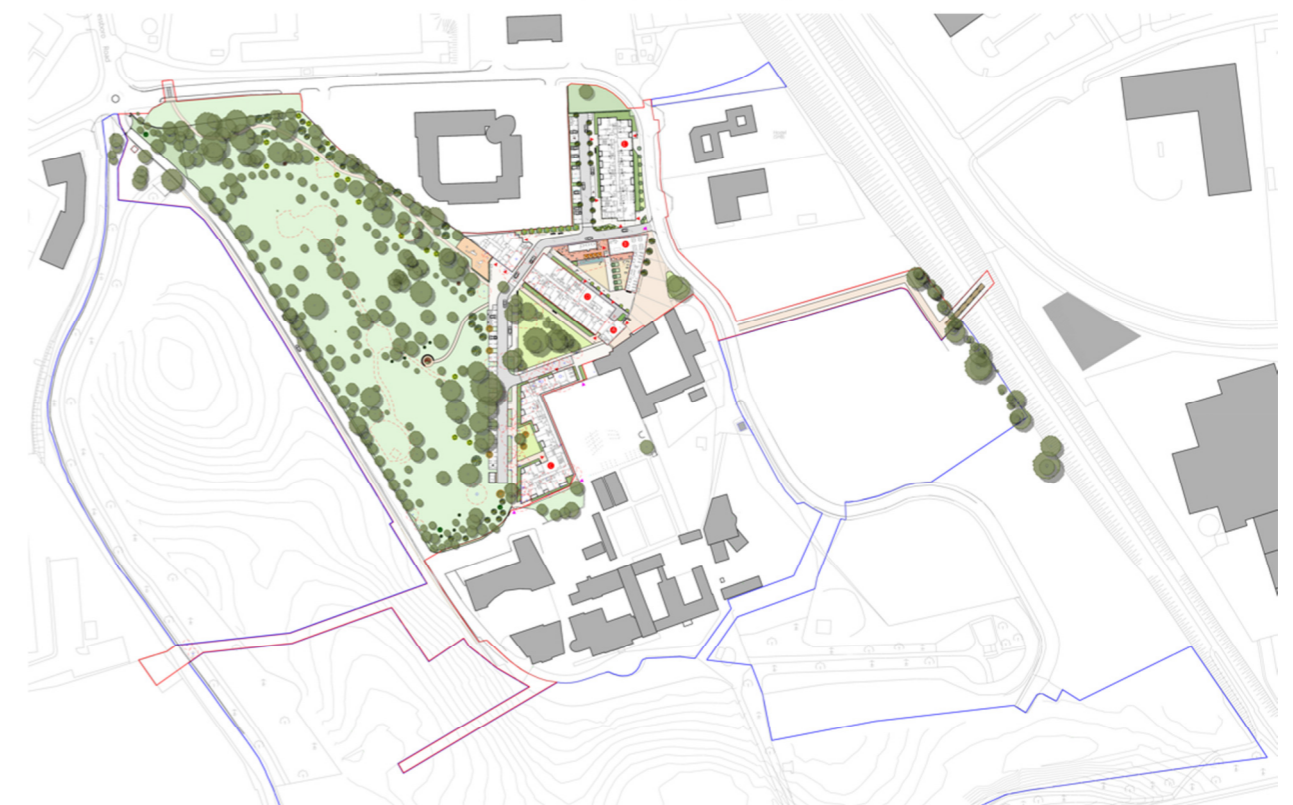
6. The Proposed Development (figure 2)

The proposed development provides for the construction of 280 apartments over 4 blocks ranging in height from 1 to 10 storeys. The development will consist of 12 no. 3-bedroom apartments, 150 no. 2-bedroom apartments, 112 no. 1-bedroom apartments, and 6 no. studio apartments. Provision is made for a creche at ground floor level in Block A, a café at ground floor level in Block B and shared communal tenant facilities including a resident’s gym, lounge, and home work areas, as well as building management facilities, plant and storage across Blocks A-D. The proposed development includes a new pedestrian/cycle bridge over the adjoining Passage West Greenway to the east, connecting into the existing down ramp from Mahon providing direct access to the greenway and wider areas. Ancillary site works include the provision of 2 no. substations, outdoor amenity areas, landscaping, 101 no. car parking spaces (98 under podium and 3 on street), 10 no. motorbike spaces, 604 no. bicycle parking spaces, bin stores, public lighting, and all supporting site development works. Vehicular access to the proposed development will be provided via the existing access road off the Bessborough Road.

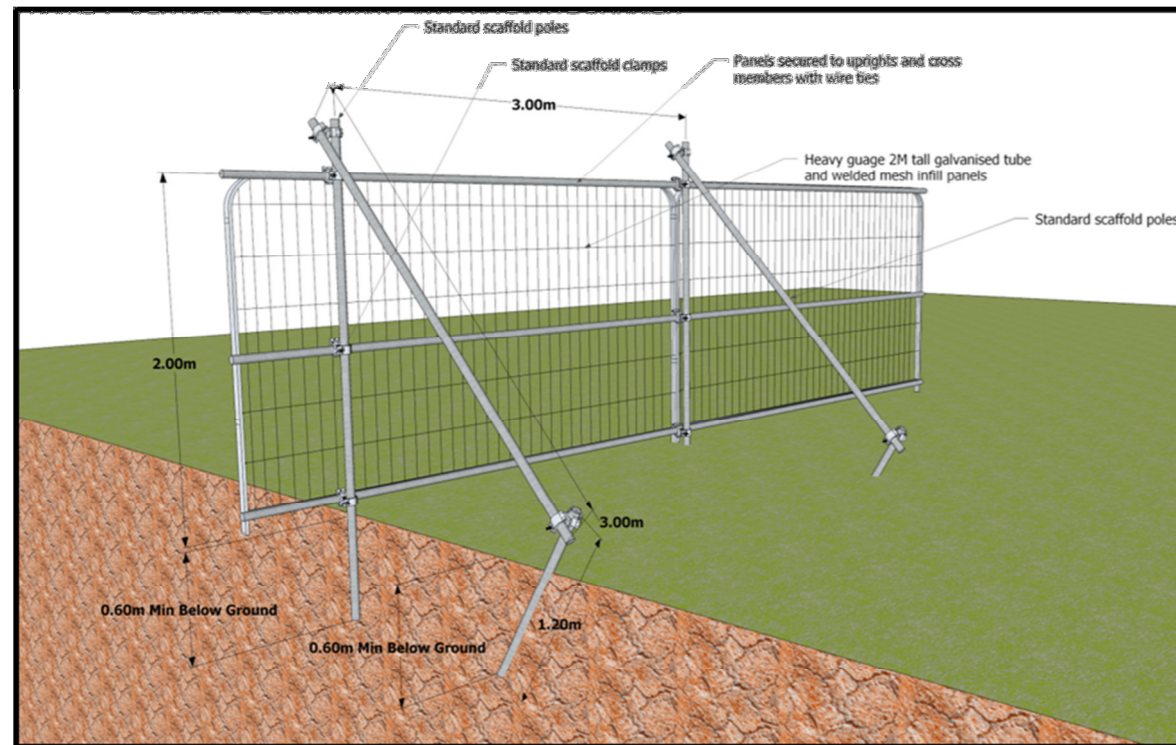
Figure 3 Default specification for tree protection barrier in accordance with BS5837:2012

<p>No dumping of spoil or rubbish, parking of vehicles or plant, storage of materials or temporary accommodation will be undertaken within the TPZs.</p> <p>All tree roots within the RPAs greater than 25mm diameter will be retained and worked around.</p> <p>Soil levels will not be increased or reduced within the RPAs of trees without prior agreement from the arboricultural consultant.</p>
General Principles to Avoid Damage to Trees	<p>All tree works will be carried out in accordance with the recommendations given in BS 3998 (2010).</p> <p>No fires will be permitted within 20m of the crown of any tree.</p> <p>No changes in soil levels will take place within the tree protection zones without prior written consent of the local authority.</p> <p>No materials, vehicles, plant or personnel will be permitted into the tree protection zones at any time without the prior consent of the arboricultural consultant.</p> <p>Any liquid materials spilled on site will be immediately cleared up and removed from the site. If liquid fuel or cement products are spilled within 2m of the tree protection zone, the contractor will report the incident to the arboricultural consultant immediately.</p> <p>The contractor will report any damage to trees or shrubs, whether caused by construction activities or from any other cause, to the arboricultural consultant immediately.</p>

- 7.4 Tree protection measures - All retained trees and hedgerows can be successfully protected during the proposed development by using robust fencing which complies with the recommendations outlined within BS5837:2012.

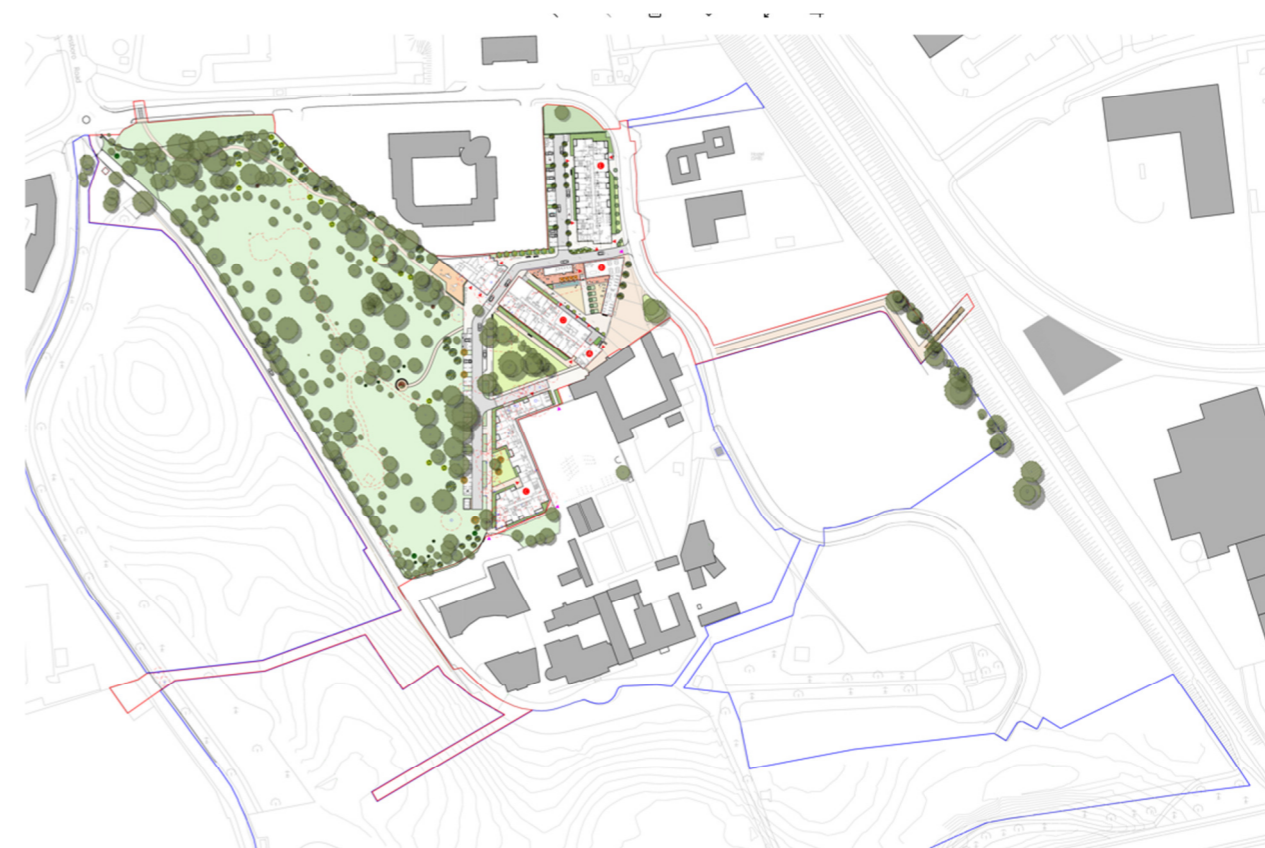
Figure 2. The Proposed Development

The development includes a publicly accessible parkland, including restoration of its historic pathways. Ancillary site works to include provision of a substation, playground and outdoor amenity spaces, landscaping, 58 no. car parking spaces, 5 no. motorbike spaces, 330 no. bicycle parking spaces, bin stores and public lighting. Vehicular access to the proposed development will also be provided via existing access road off the Bessborough Road.

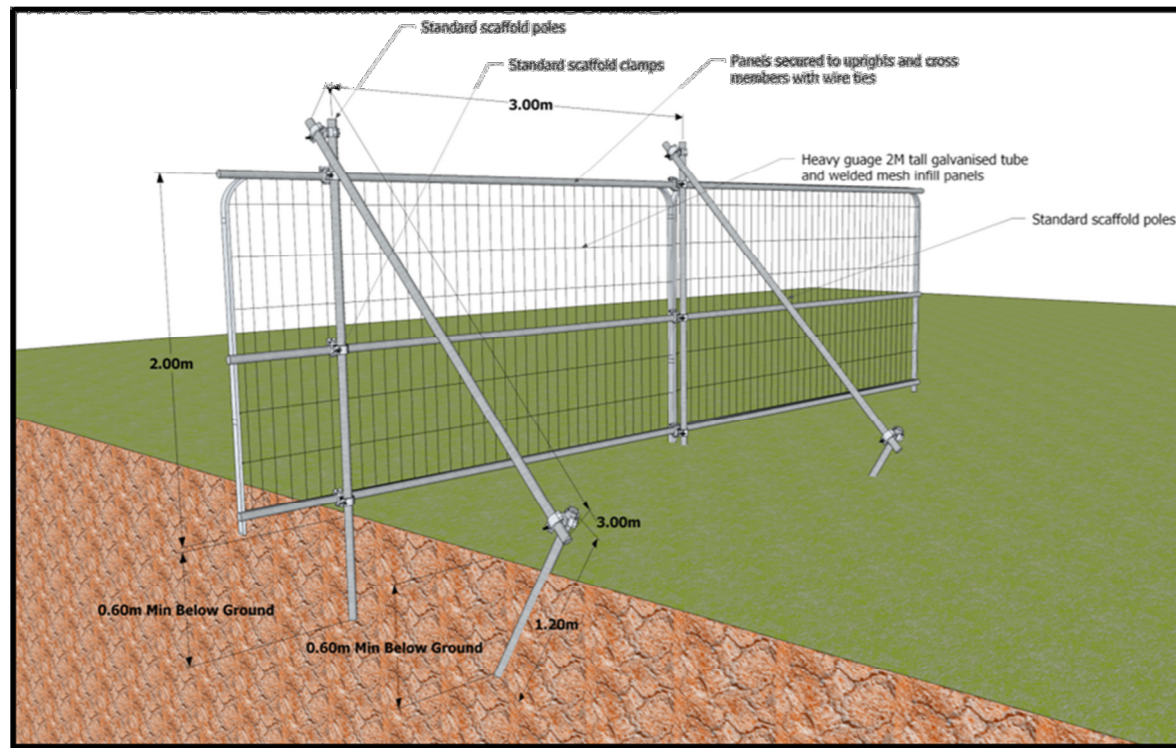
Figure 3 Default specification for tree protection barrier in accordance with BS5837:2012

<p>No dumping of spoil or rubbish, parking of vehicles or plant, storage of materials or temporary accommodation will be undertaken within the TPZs.</p> <p>All tree roots within the RPAs greater than 25mm diameter will be retained and worked around.</p> <p>Soil levels will not be increased or reduced within the RPAs of trees without prior agreement from the arboricultural consultant.</p>
General Principles to Avoid Damage to Trees	<p>All tree works will be carried out in accordance with the recommendations given in BS 3998 (2010).</p> <p>No fires will be permitted within 20m of the crown of any tree.</p> <p>No changes in soil levels will take place within the tree protection zones without prior written consent of the local authority.</p> <p>No materials, vehicles, plant or personnel will be permitted into the tree protection zones at any time without the prior consent of the arboricultural consultant.</p> <p>Any liquid materials spilled on site will be immediately cleared up and removed from the site. If liquid fuel or cement products are spilled within 2m of the tree protection zone, the contractor will report the incident to the arboricultural consultant immediately.</p> <p>The contractor will report any damage to trees or shrubs, whether caused by construction activities or from any other cause, to the arboricultural consultant immediately.</p>

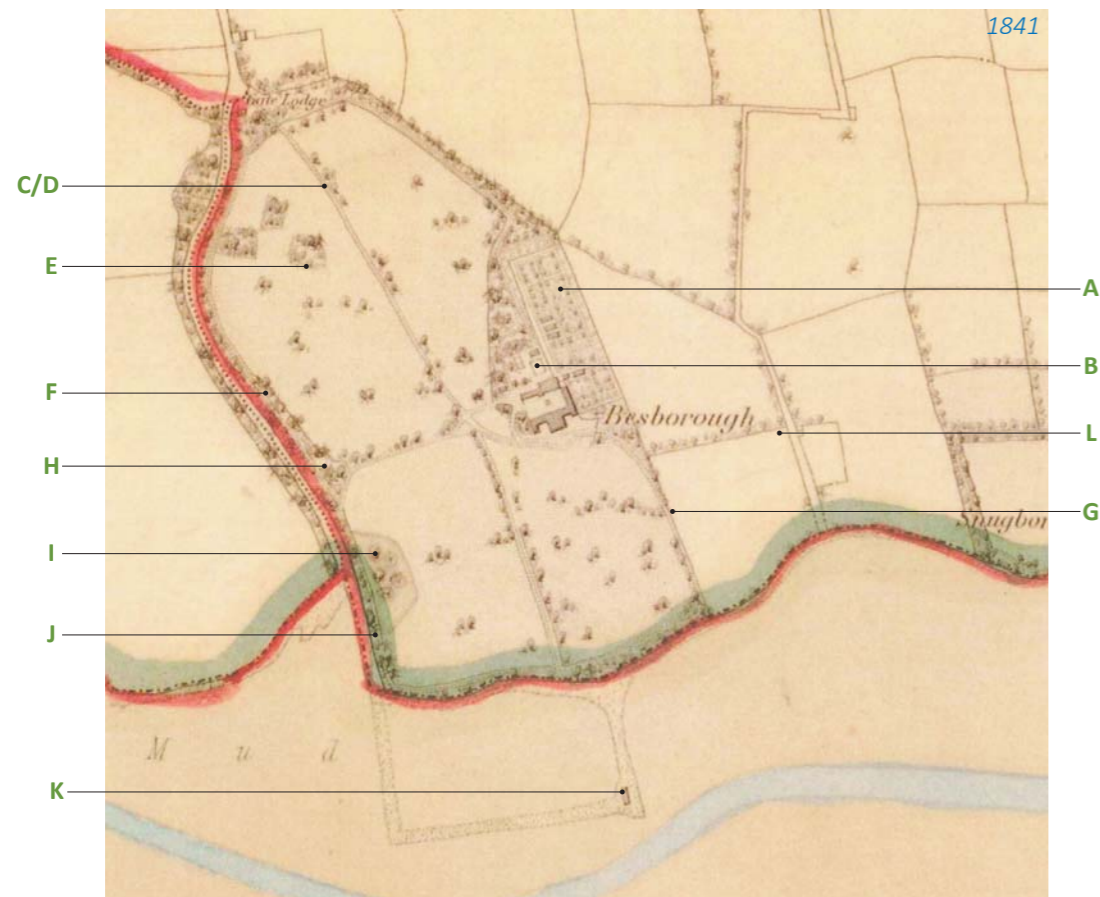
6-inch Ordnance Survey map 1st Edition (1841). The shaded area indicates the demesne lands. The two parcels to the east may have been used by Besborough, but they do not form part of the original demesne designation.

A - The structured parterre garden is offset from the main house, indicating that it was likely a functional garden and not for ornament. It also contains grow houses close to the house, whereby aesthetic design would have placed them at the rear periphery of the garden.

L - The two agricultural parcels east of the house are separated by a hedgerow. This would not form part of the Folly avenue we see today. Where the hedgerow meets the track, some have argued that this square is the Folly. It is an odd juxtaposition and would be highlighted grey if it were the Folly. A wave of follies (particularly castle follies) arose across Ireland during the famine years of the late 1840's.

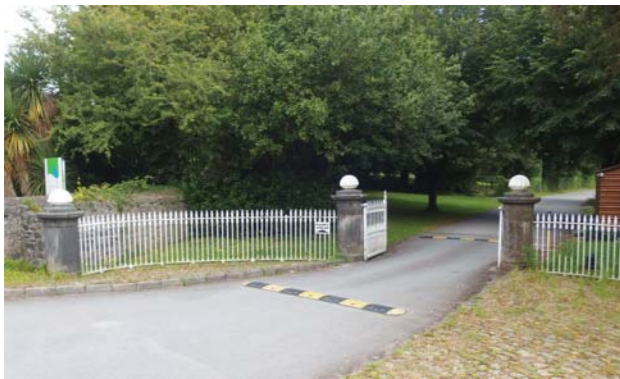
Item: Entrance Piers
Comments: Scale and offset to each other
Category: 4

Item: Entrance Wrought Iron Fence
Comments: Curved form and finial design
Category: 4

Item: Cobble Paving
Comments: Natural stone, modern addition
Category: 2

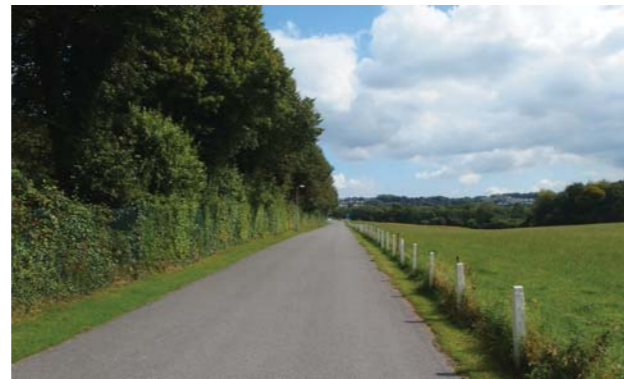
Item: Tarmac Entry Avenue
Comments: Alignment and scale
Category: 3

Item: Concrete Post and Wire Fence
Comments: Later generation fence
Category: 1

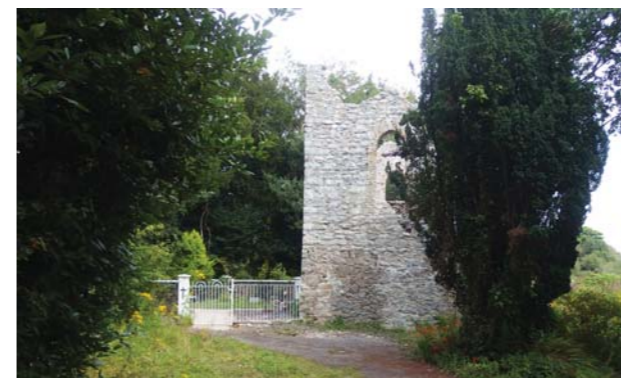
Item: Stone Folly (Castle Keep)
Comments: Mid-1800's, quality, romanticism
Category: 5

Item: Graveyard
Comments: 1920's; cultural
Category: 5

Item: Yew Tree
Comments: Mid-1800's, obscures view but culturally appropriate, moderate health
Category: 4

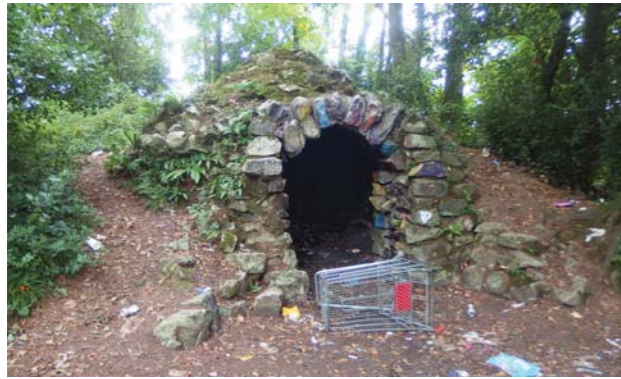
Item: Ice House
Comments: Style and setting, intact but used as a rubbish dump and graffitied
Category: 5

Item: Surrounding Woodland
Comments: Original, shelter and character
Category: 5

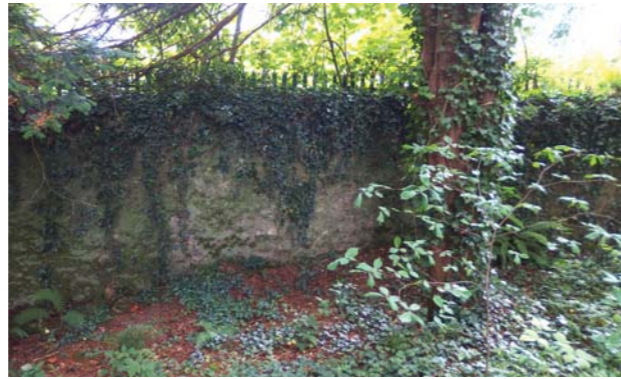
Item: Stone Boundary Wall
Comments: Stone and plaster to 2.5m ht.; compromised at several locations
Category: 5

Item: Woodland Understorey
Comments: Clean, but only modest diversity
Category: 3

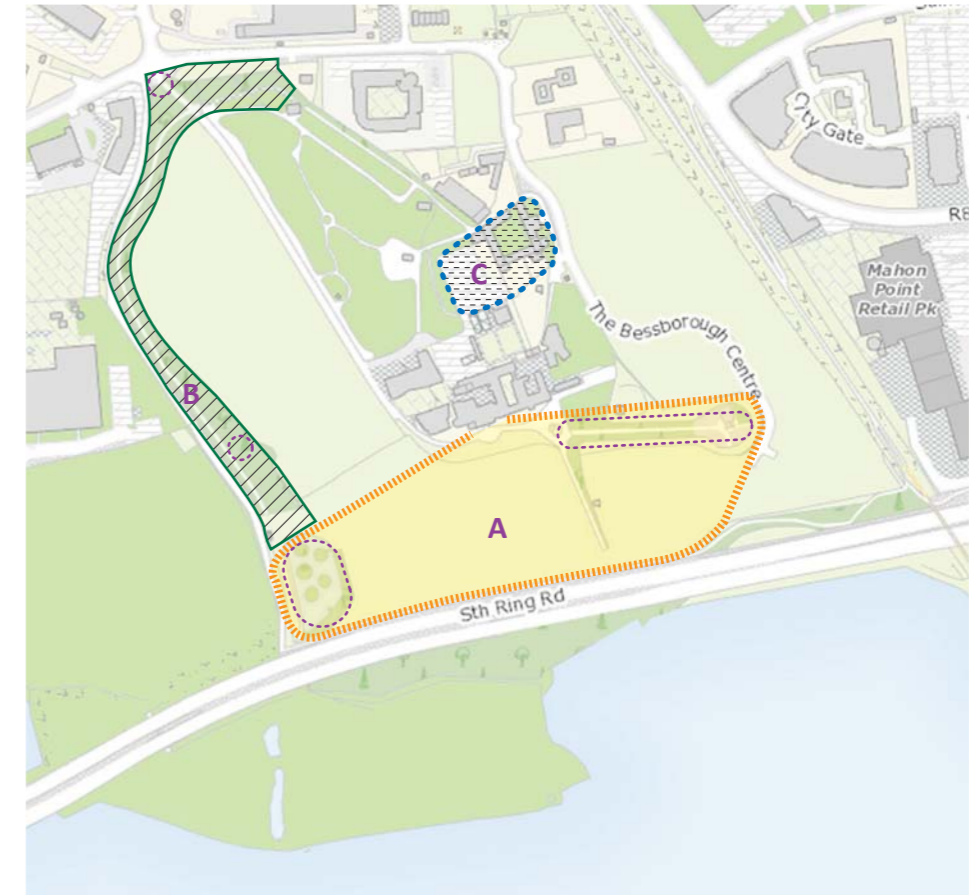
Diagram of landscape zones that should be protected and enhanced to enable retention of historic landscape character. Areas not highlighted have a degree of flexibility to receive landscape change or built development.

ZONE A - The historic house has undergone an enormous amount of change to the rear and sides, but the one constant is the open landscape to the front (south) of the house. These contextual relationships can be extended into the landscape. The lands to the south are vital to keep open, while the lands to the east, west and north can tolerate development without diluting the historic landscape strengths. The zone includes the full extent of the pond to the west and the Folly to the east. It is this zone that should be classified as the "Landscape Preservation Zone".

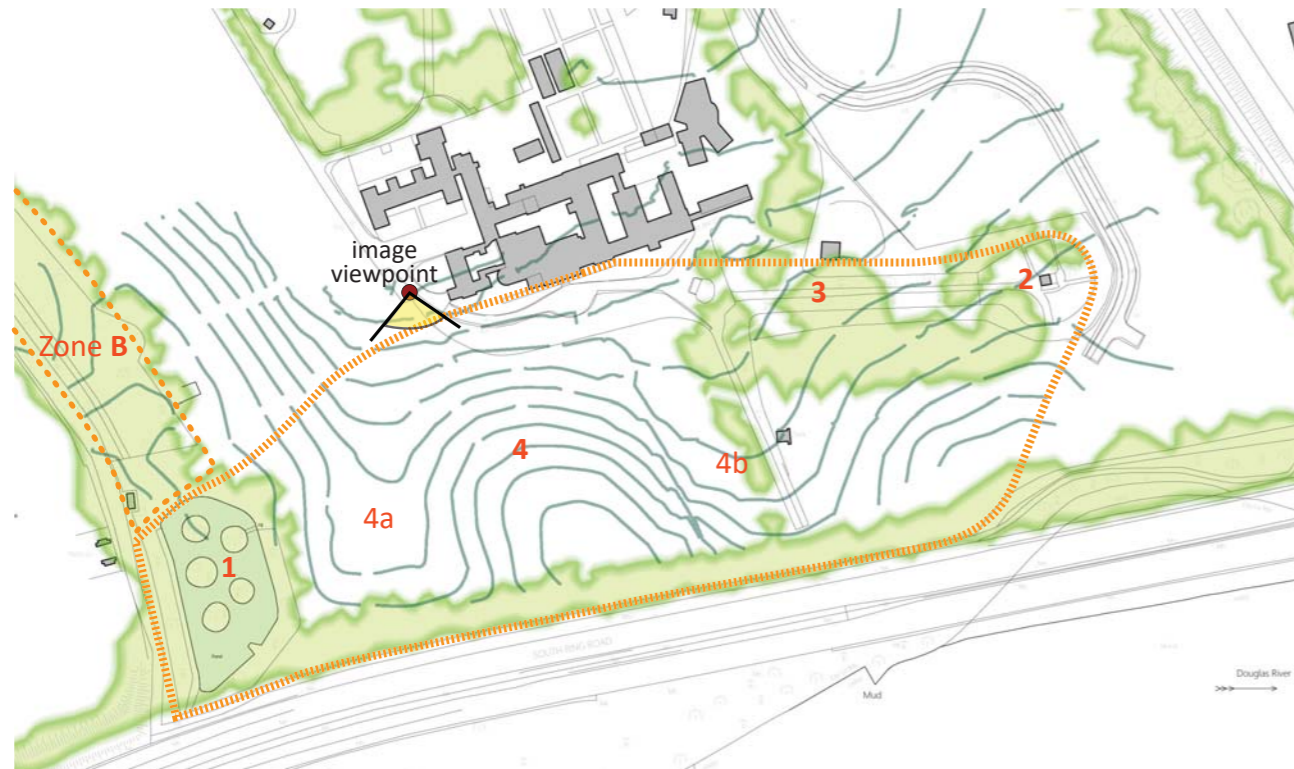
Diagram depicting an accurate extent of the proposed Landscape Preservation Zone. The base image includes structures, landscape features, 1m contour lines and aerial extent of tree canopies.

Criteria 1 - The Pond - The entirety of the pond needs to be included with future visual link to the house (after mitigation).

Criteria 3 - Folly Avenue - Includes 20m north of the path for suitable tree protection.

Criteria 4 - Landform - More important than a line on a plan, the lay of the land defines the southern open space with a distinct 'bowl' feature. The knolls to either side (4a and 4b) must be included to enhance the effect. The northwest extent of the LPZ reflects a lowpoint of the receding knoll in the undulating landscape.

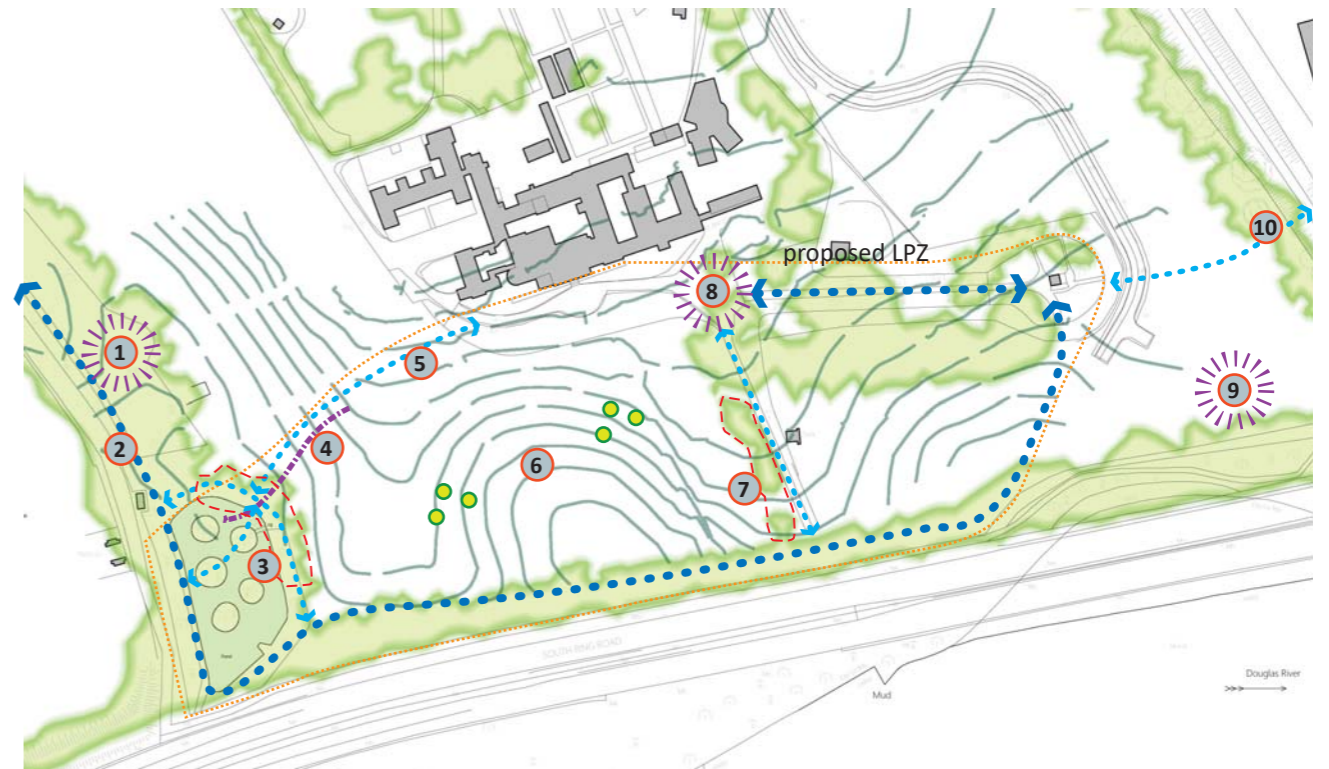
Diagram illustrating mitigation measures to improve amenity and interpretation.

Mitigation 1 - Ice House - Full cleaning and resculpting of base per Archaeologist guidance. Provide interpretation. Provide a visual gap to new development for secondary supervision.

Mitigation 10 - Provide a pedestrian link over the railway amenity path, for ease of access to Mahon office and retail area.

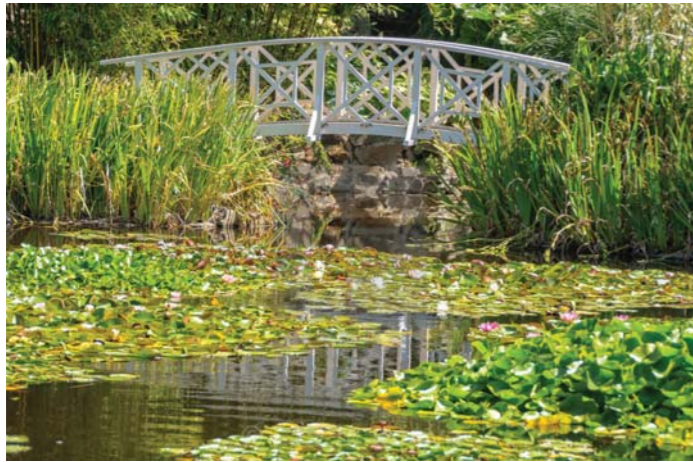
The aim is to restore the pond with a character pertinent to the time period where it received greatest amenity interaction. Reinvigoration of the pond water should be coupled with Laurel removal on the islands and new footbridges to enhance the amenity. This image illustrates an ambience that we want visitors to experience.

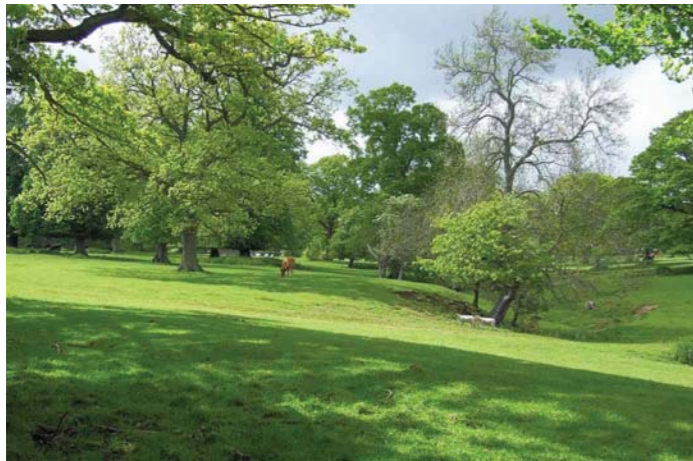
Pond restoration is intended to work in tandem with site stormwater solutions. Creating a sustainable drainage system that can remove surface water naturally and feed the pond with regular, fresh water is the desired design technique. This image illustrates an undulating parkland collecting and mitigating stormwater.
