BESSBOROUGH, CORK

Cultural Heritage

Appendix 10.2: General Photographic Record

1. Introduction

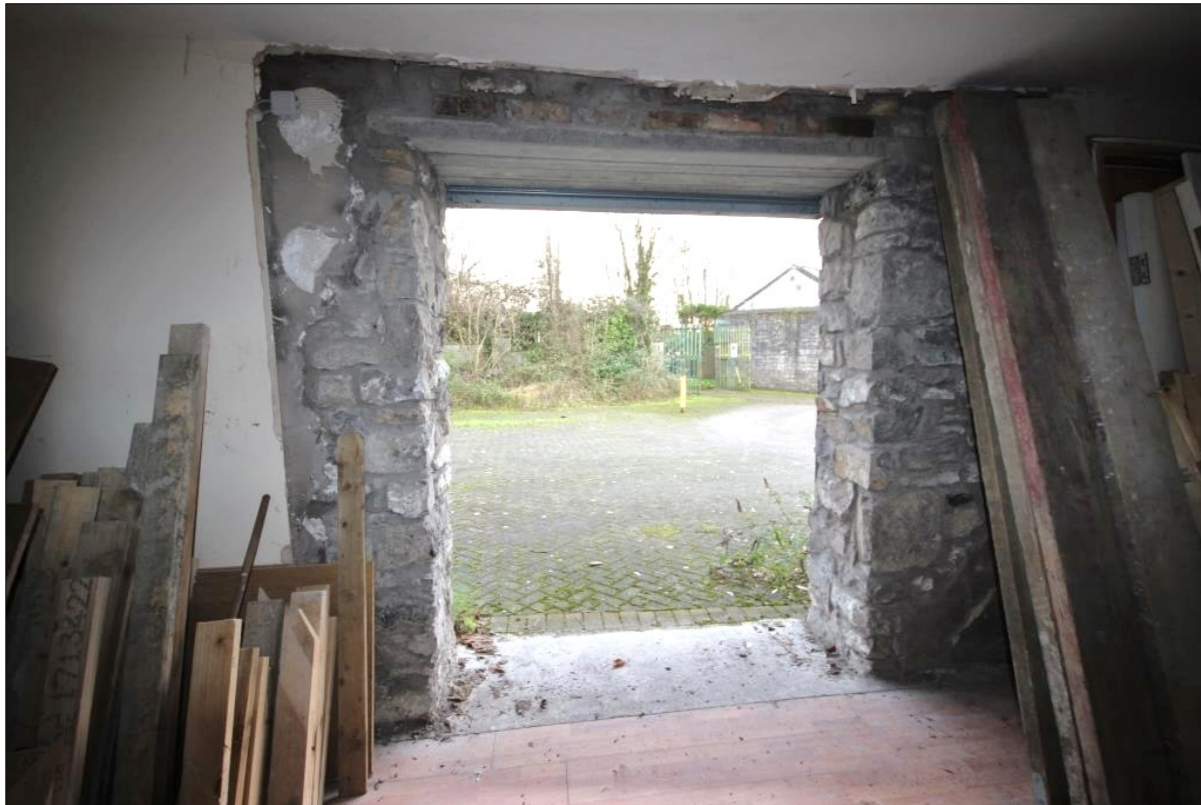
Plate 16: Entrance on eastern elevation of Building B

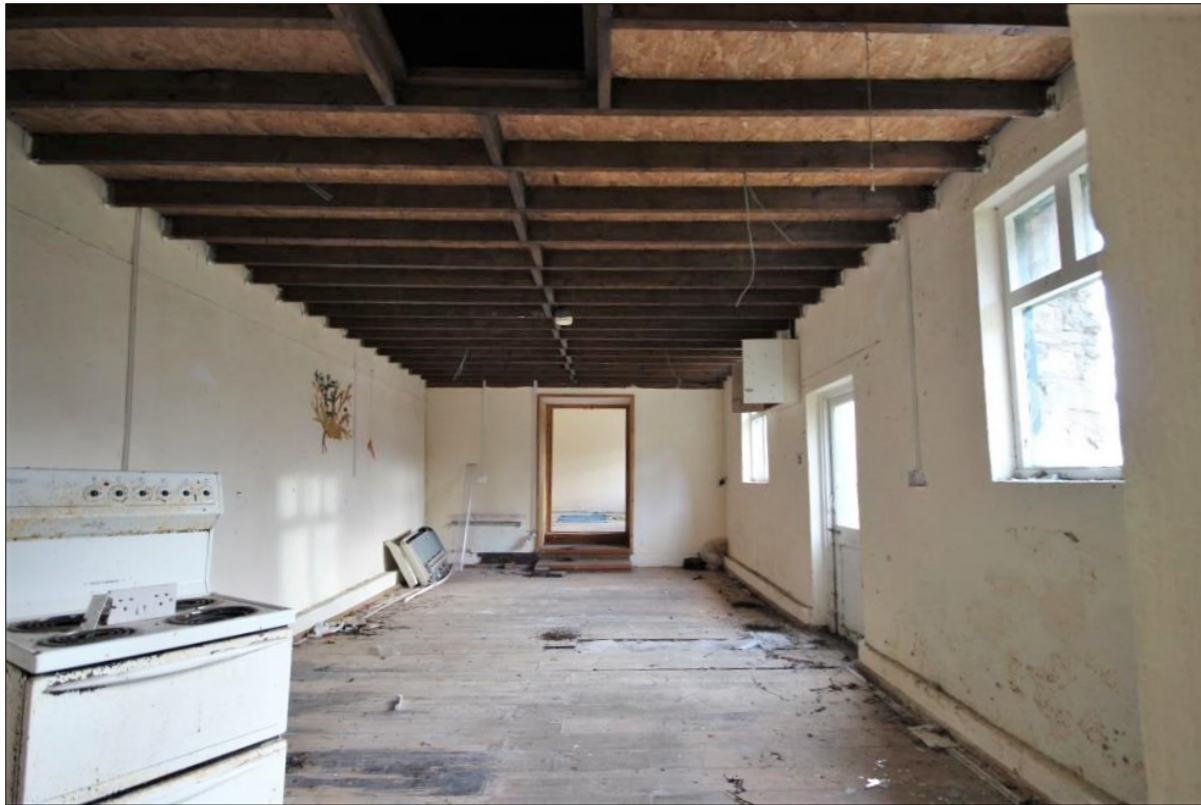
Plate 32: Interior of Building F with modern floor, ceiling and wall finishes
